PERIOD COMMERCIAL BUILDING RENOVATION IN FARNHAM –

A Full-Scope Transformation by Marshels

Project Type: Specialist Decoration, Renovation, Roofing, Structural Work, Air Conditioning, and Drainage

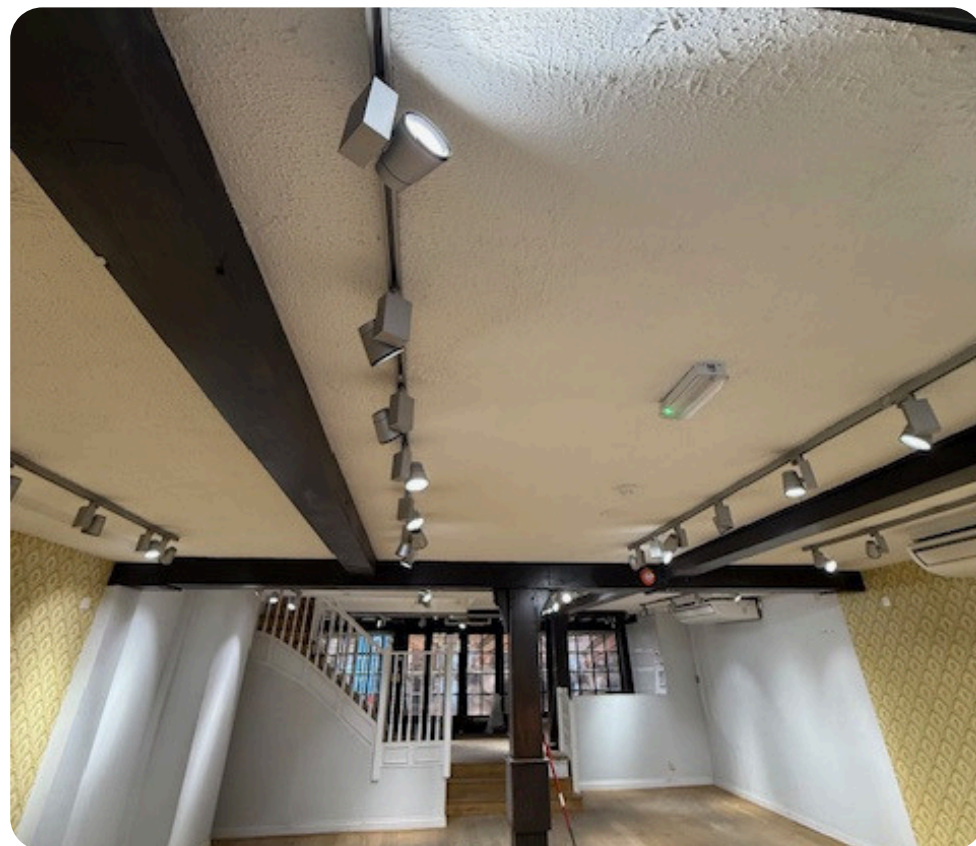
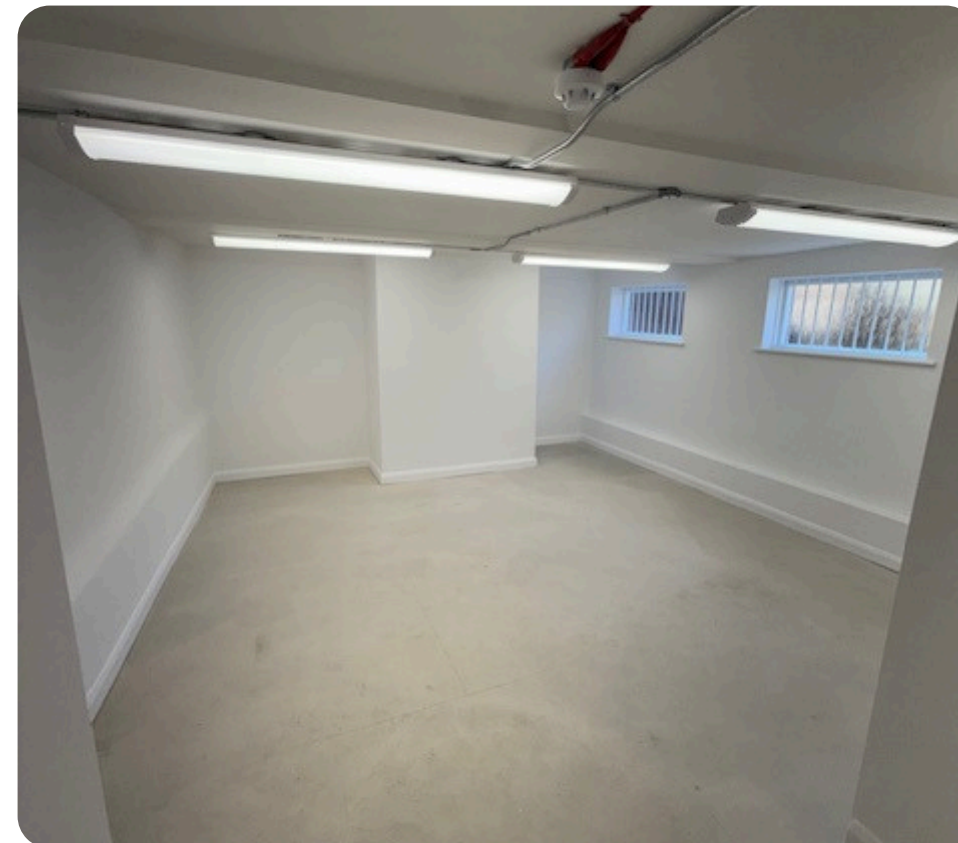
A storage room cluttered with shelving was stripped back. We embraced an industrial aesthetic, installing surface-mounted electrical conduit and pipework, laying a self-levelling screed floor and refreshing the walls with new plaster and industrial-style decoration.

Internal non-structural elements were removed to open up the floor plan and create flexible, usable spaces suitable for a commercial environment.

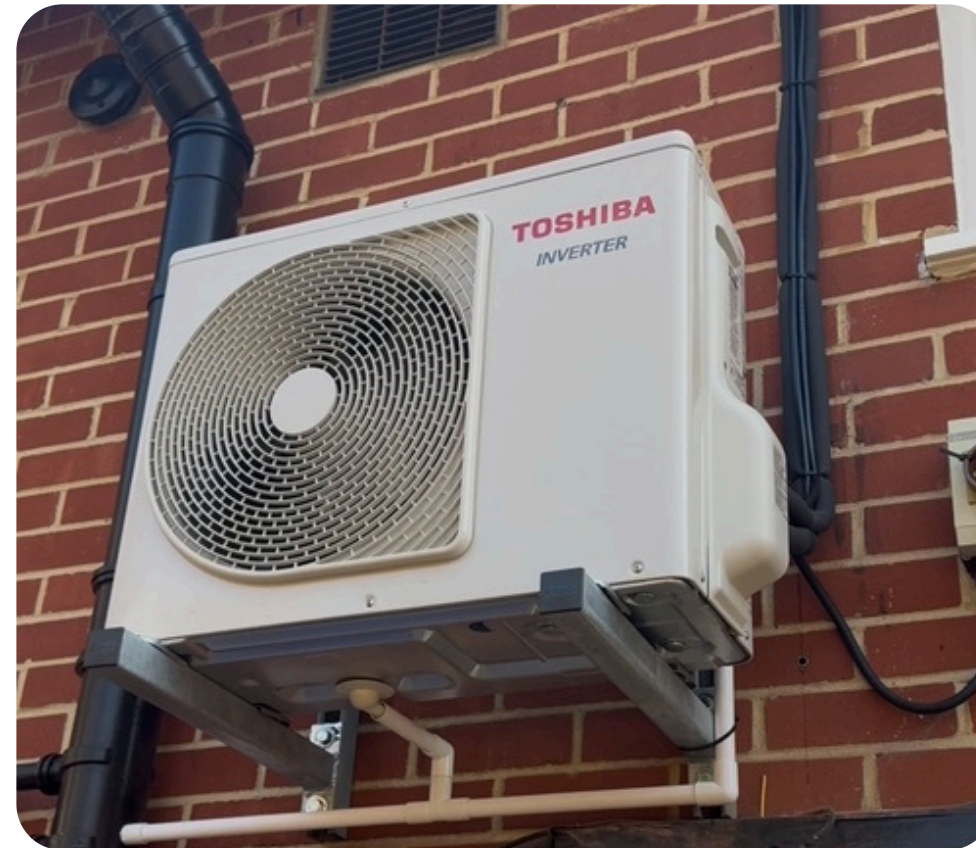
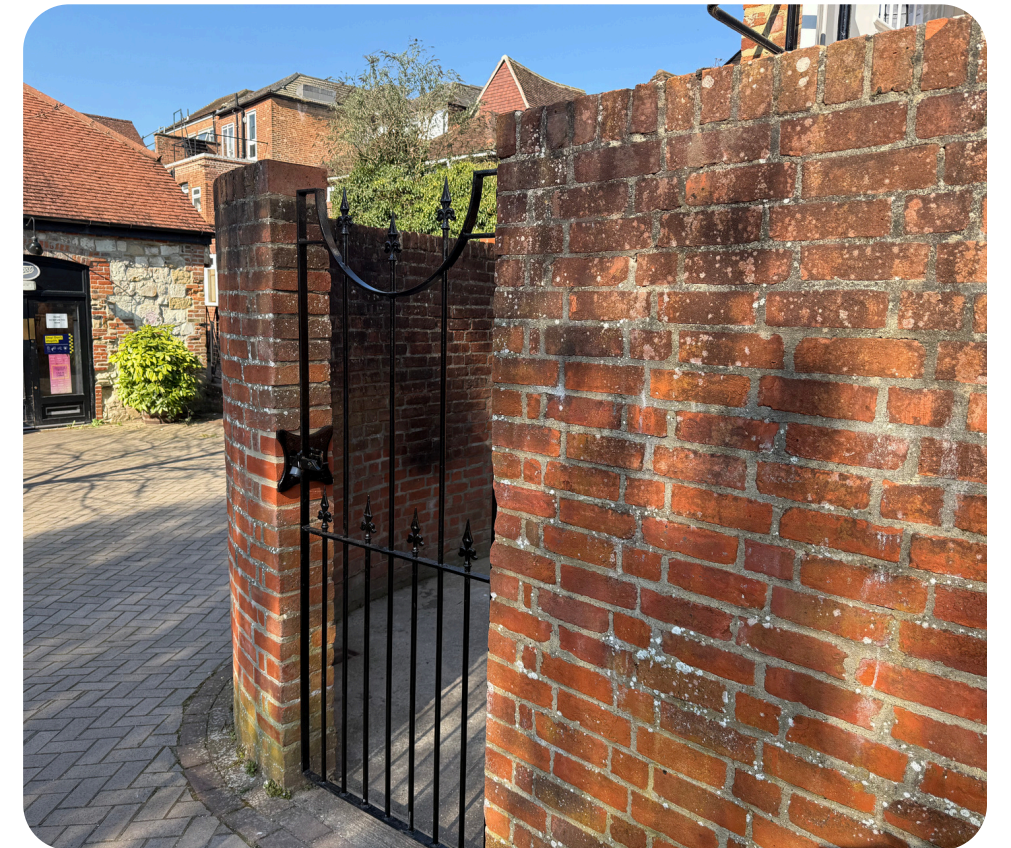
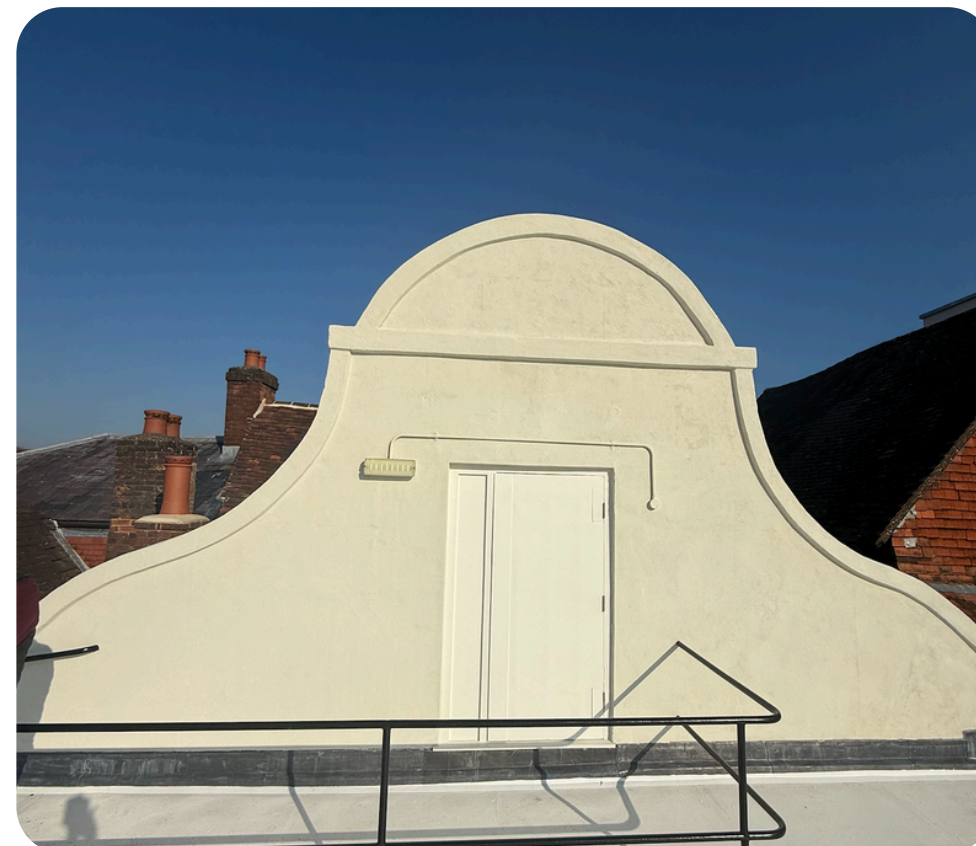
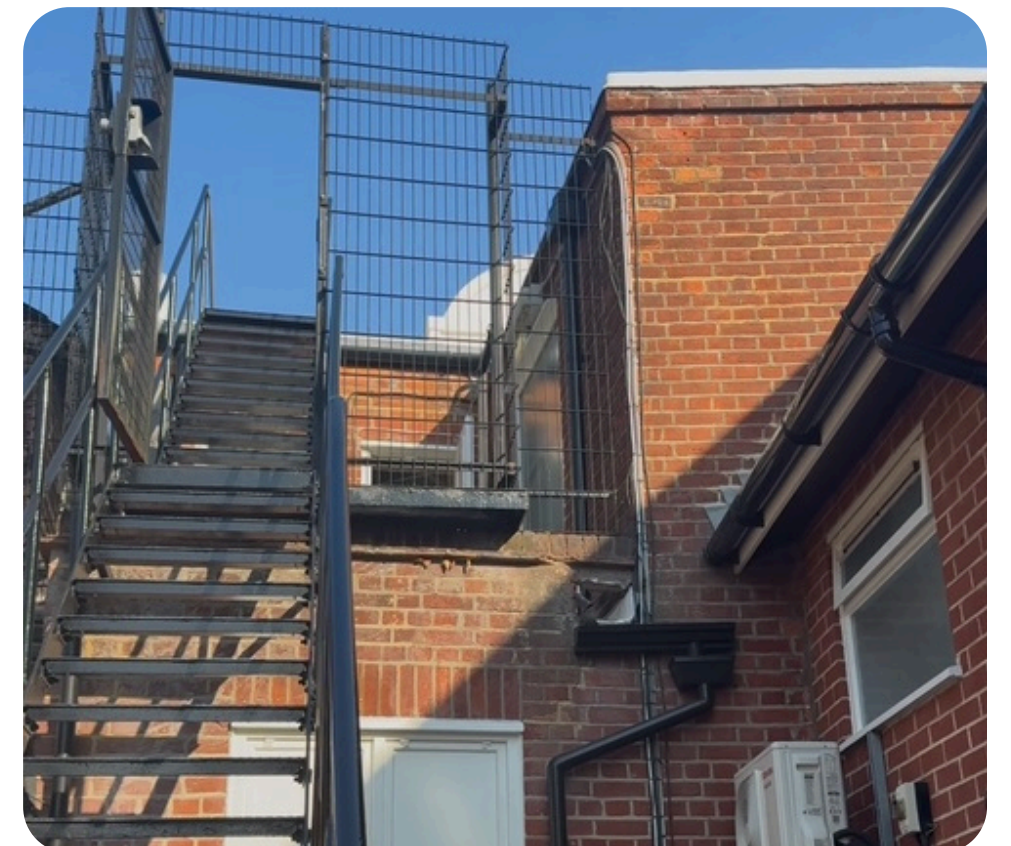
Exterior railings were repainted to refresh their look and extend their lifespan.

The rear entrance was previously unusable due to poor drainage and invasive plant growth. We rebuilt sections of the wall, installed new guttering and resolved all drainage issues, transforming the space into a functional access point.

A full camera survey of the drainage system was carried out to identify issues. We made targeted improvements to ensure a reliable flow and prevent future water damage.

All loose and hanging electrics were secured neatly using cable trays, improving both aesthetics and safety throughout the premises.
